Smoke and Dye-Water Observation Summary

Western Run Pilot Project - Baltimore Maryland

INSPECTION REPORT

REMARK: DYE TEST 70 B 2

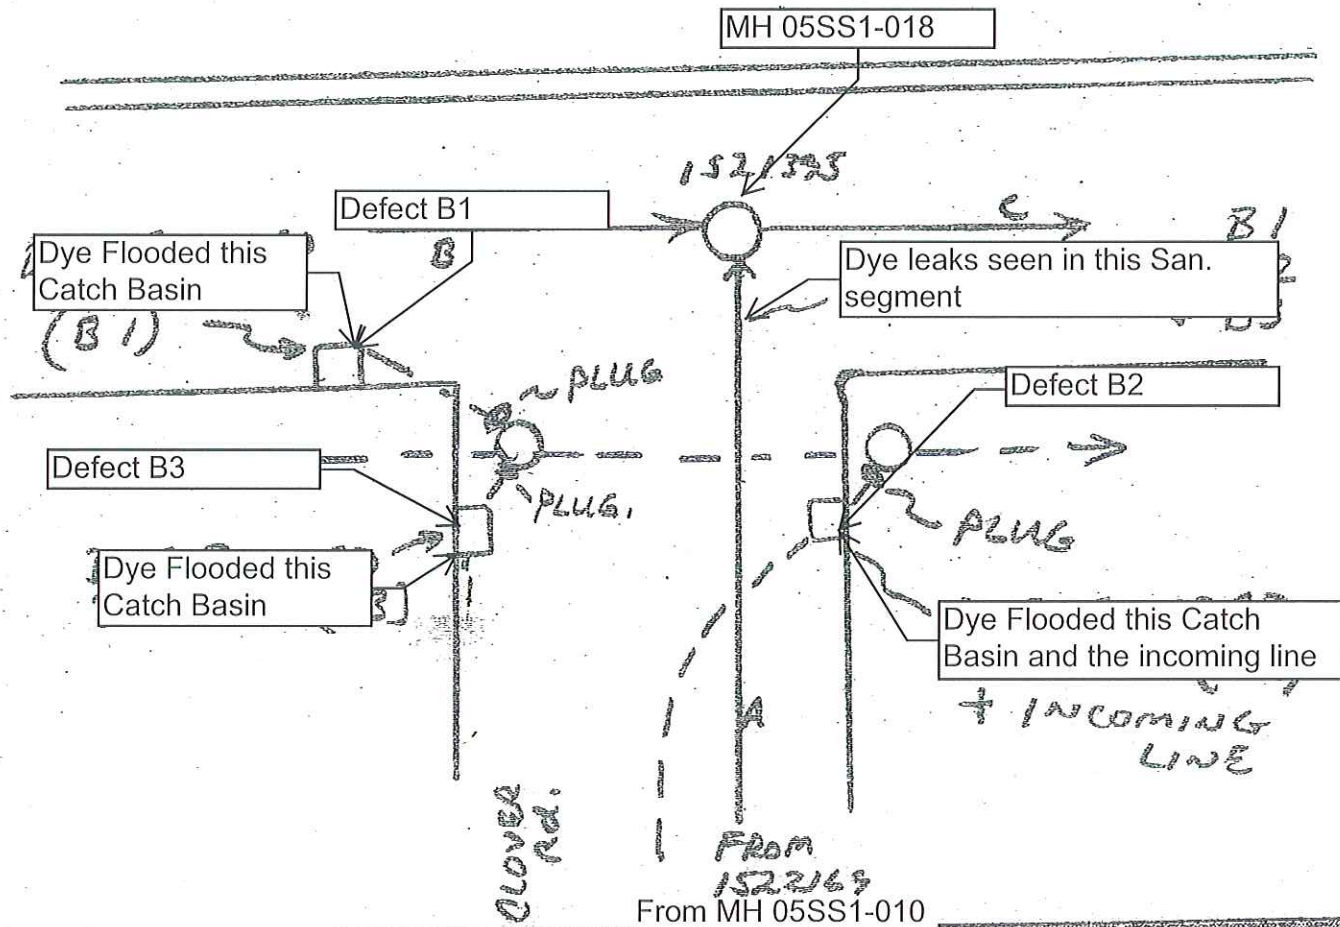
Sketch (NTS)
Dye Test 70

Additional Comments: THE SAME JOINT LEAKED FOR ALL THREE FLOODING, TUED IT TWO TIMES.
40.65' TOTAL TV FT.

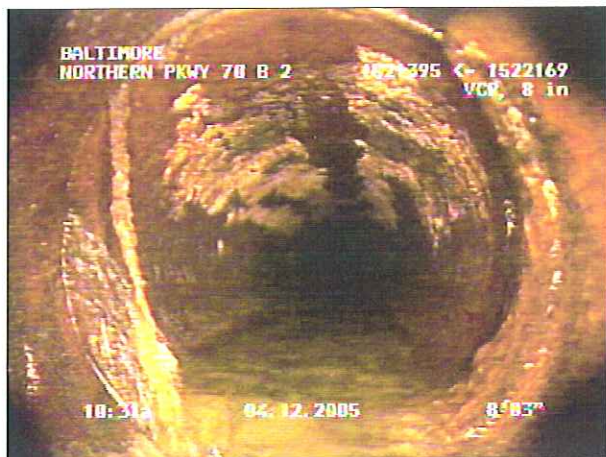
IMAGE: 9a, TAPE #: JAM 4, 00:05:57
8.25FT, Infiltration Gushing at joint from 01 to 09 o'clock

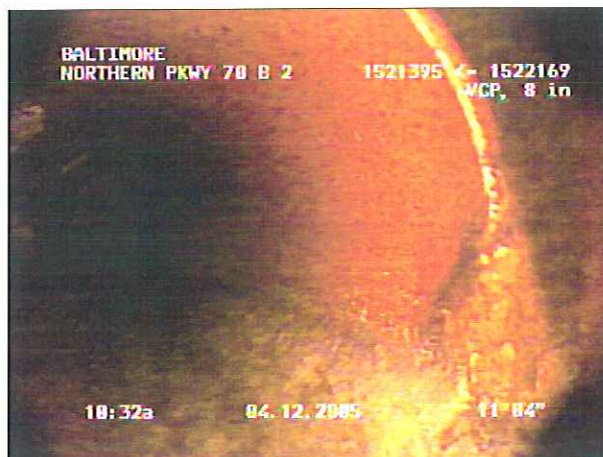
IMAGE: 10a, TAPE #: JAM 4, 00:06:29
11.37FT, Infiltration Seeping at joint at 04 o'clock

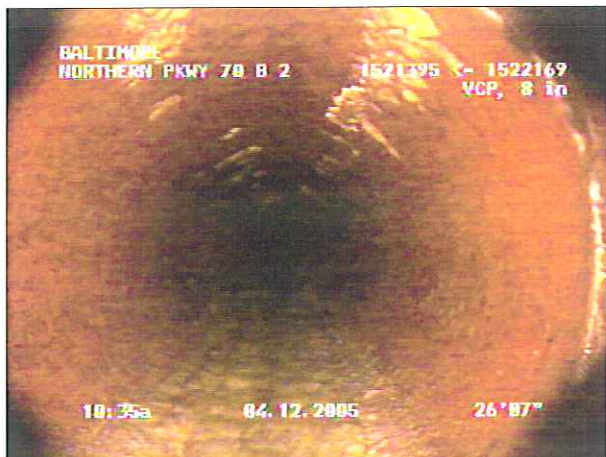
IMAGE: 11a, TAPE #: JAM 4, 00:07:58
26.56FT, inspection ends, NO MORE LEAKS SEEN FROM DYE TEST.

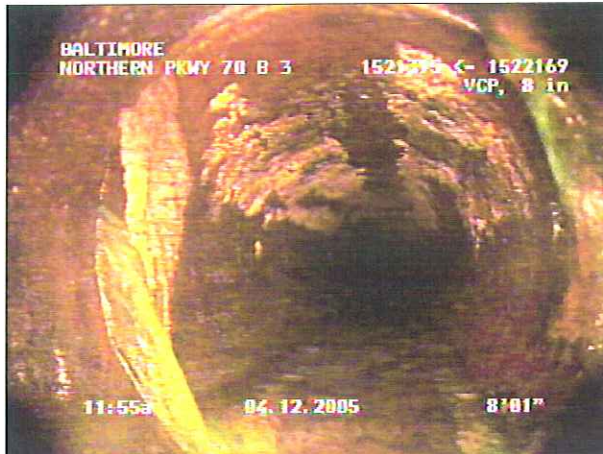
IMAGE: 13a, TAPE #: JAM 4, 00:10:07
8.05FT, Infiltration Gushing at joint from 01 to 09 o'clock
